REHOBOTH BEACH CITY HALL

MEP Systems Evaluation

Allen & Shariff Engineering, LLC
205 East Market Street
Salisbury, MD 21801

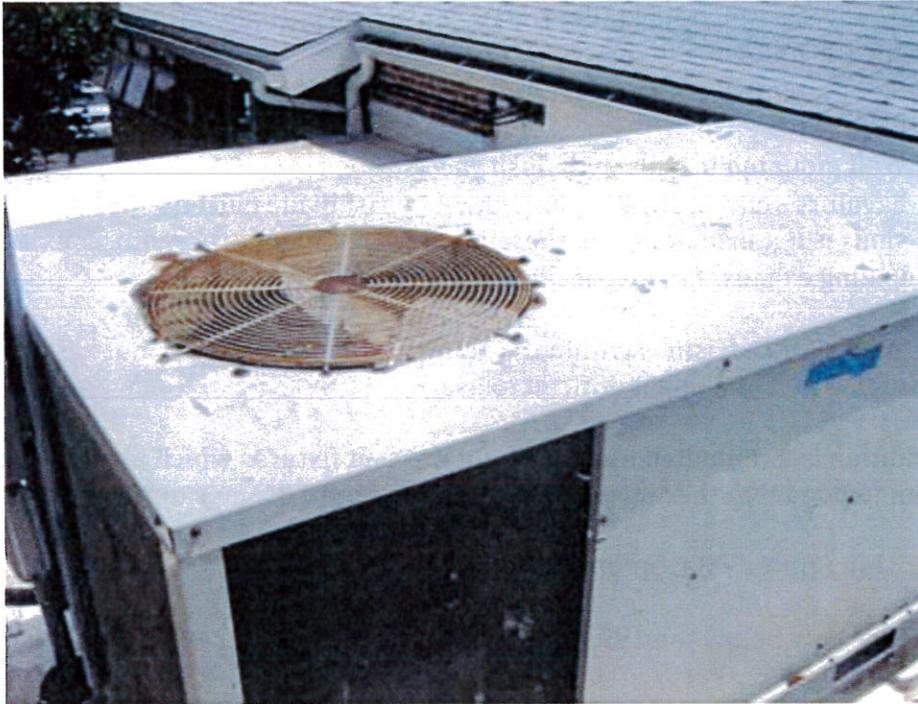
- The first floor office space of City Hall is served by a rooftop unit, which is located above the link. The serial number indicates the unit was manufactured in 1996, is in fair condition, but is approaching the end of its useful life expectancy. The thermostat is within the open office area, furthest from any exterior exposure. A window air conditioning unit has been added to the rear corner office.
- Two window air conditioning units are installed above the front entry doors to the Police Department.
- The Courtroom is served by a floor-mounted console unit, with a remote grade mounted condensing unit.
- The basement Processing Room of the Police Department has a window air conditioning unit.
- Most of the split system equipment appears to have been replaced in 2004, and is half way through their useful life expectancy.

Office Area Rooftop Unit installed on the roof of the link.

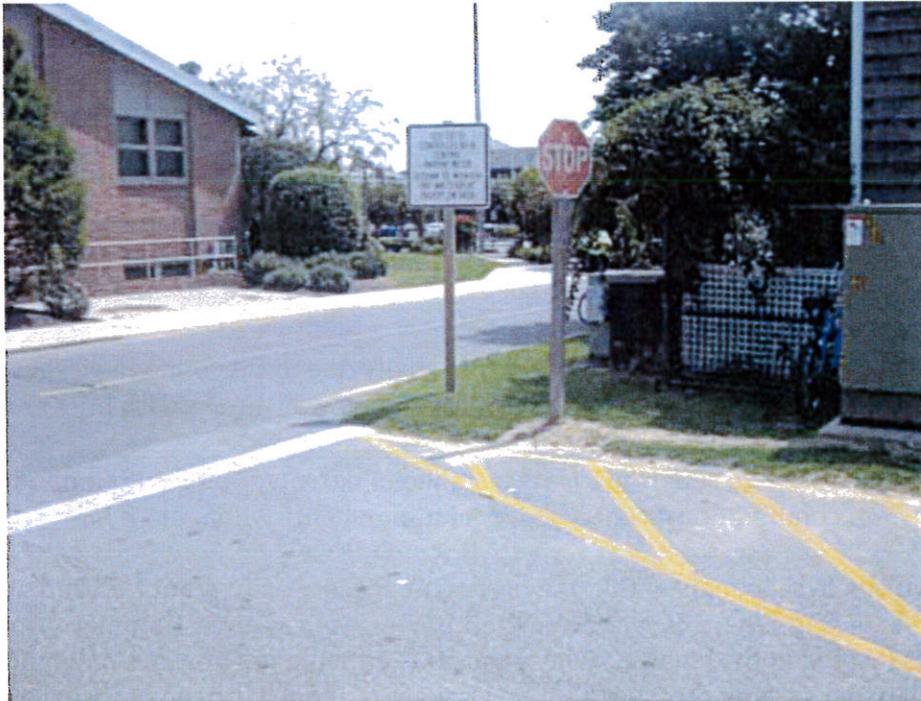
to confirm that it is not asbestos. Outside air is not provided to this unit. The remote heat pump condenser is grade mounted, across the access driveway, adjacent to another unit serving the other air-handling unit in this basement area.

Condensing Units Across Driveway
These two units serve the air-handling units in the basement of City Hall.

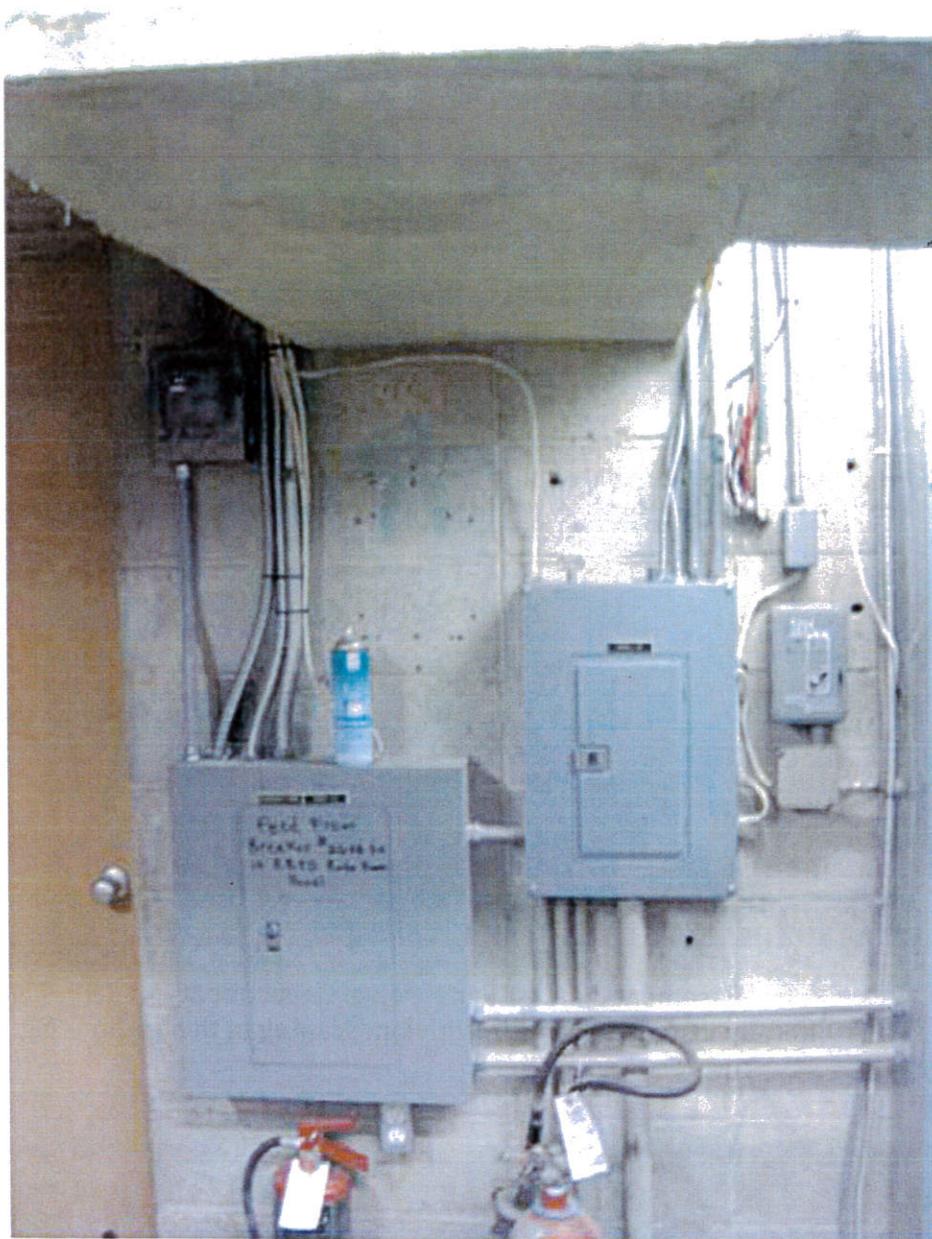
- The majority of the basement spaces and interior first floor rooms are served by split systems, piped to grade mounted condensing units.
- The basement Commissioner's room is served by a dedicated air handling unit in the adjacent mechanical / electrical room. Minor modifications have been done to this system, with a rerouting of one of the supply ducts to accommodate a new electrical panel. The duct insulation needs to be tested

- The existing electrical panels appear to be in good working order and functioning as expected.
- It was noted that Romex had been used in the mechanical / electrical space and that it appeared to continue to above the drop tile ceiling in the adjacent

meeting room. The use of this wiring above the drop ceiling is not allowed per current code.

Supply Duct for Commissioner's Room
Code violation as it is above electrical panels and insulation is subject.
Romex cable going to above drop ceiling.

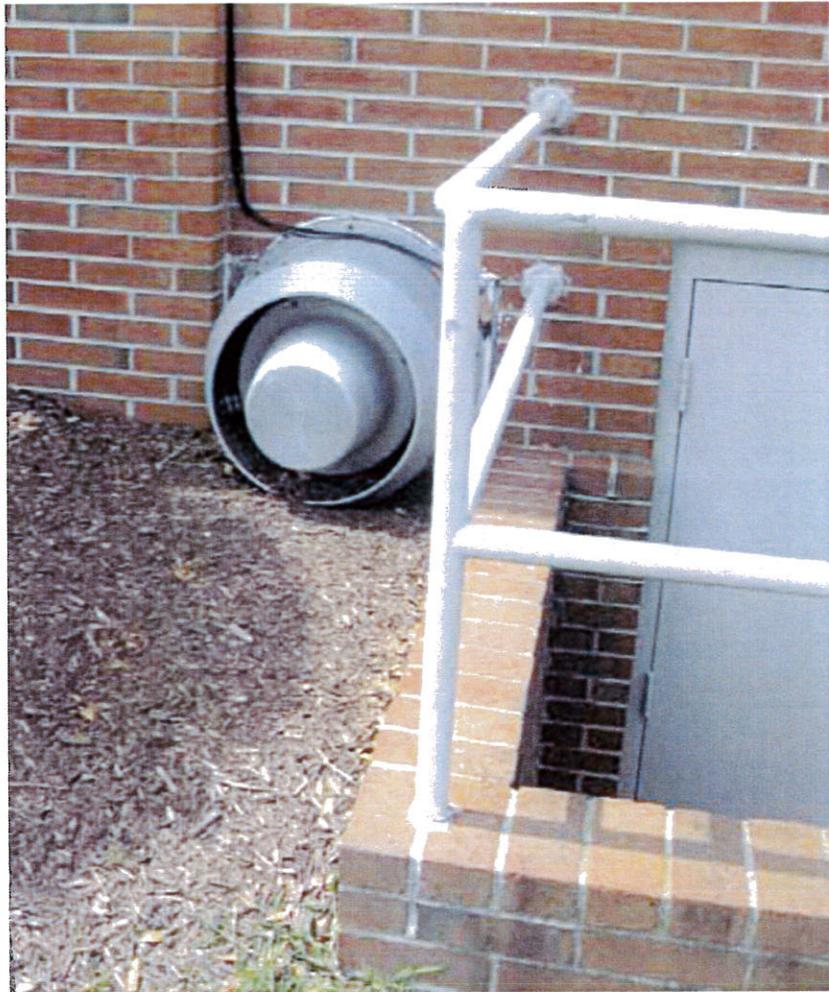
Basement Exhaust Fan – Police Department
Fan is literally installed on grade with landscaping in the fan housing.

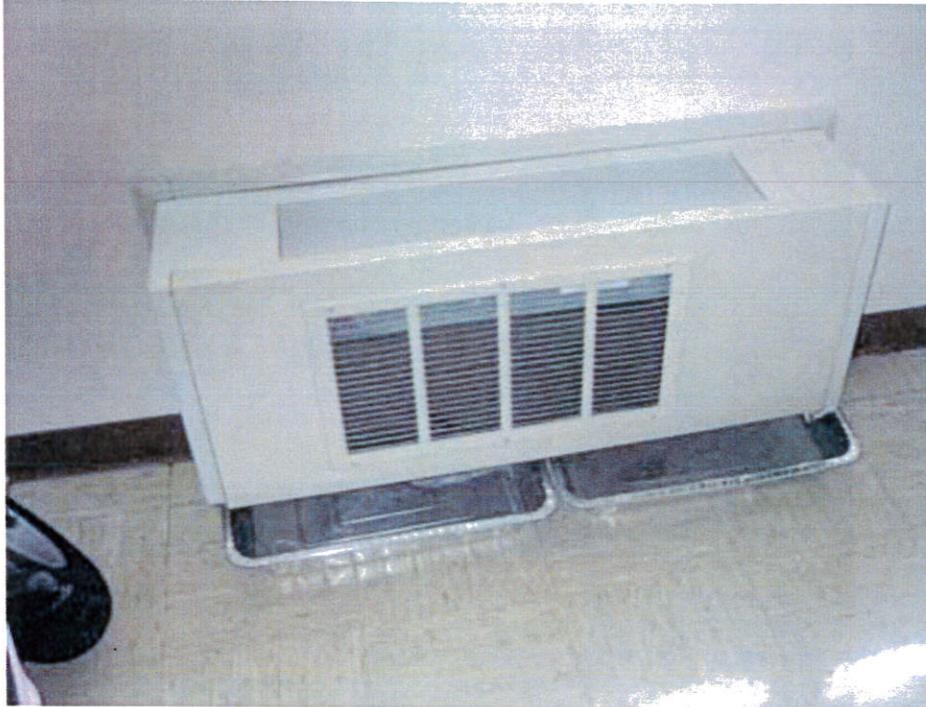
Meeting rooms in the 1993 addition are served by PTAC's. The larger room (in the Southeast corner) required a recent replacement of the PTAC's to a split system, and this room does not have any provision for system level outside air.

Existing Thru-wall Packaged Unit
Unit is apparently leaking as observed by the added pans. Some of these units have already failed and been replaced by split systems.

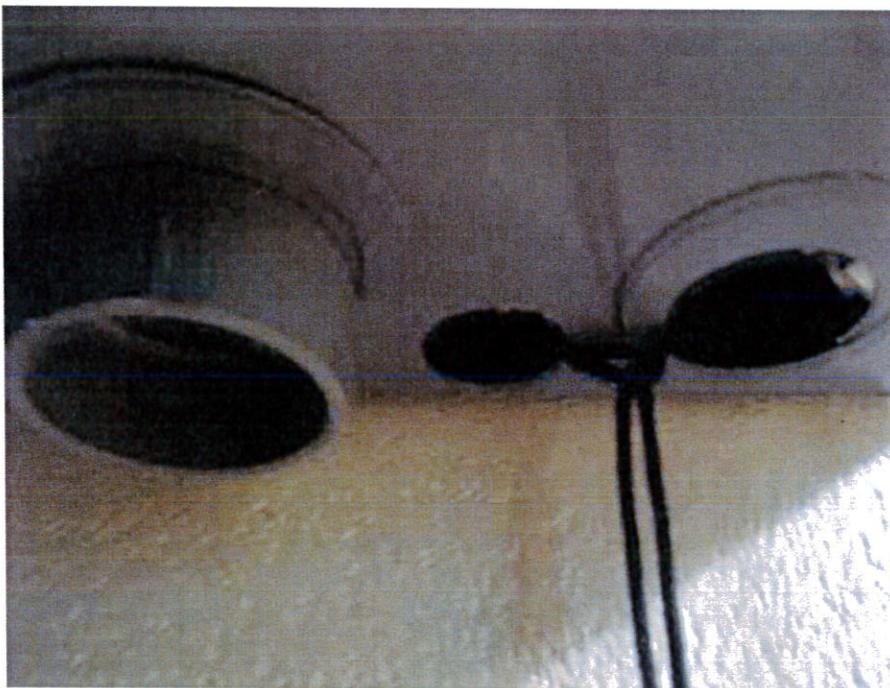
The convention center is served by an 800A service located in the rear of the stage. This panel provides service to several panels located on the stage and also panels located in the shop and the kitchen. The electrical panels appear to be accurately identified and in good working order. There are several disconnects located on the stage used for show power as these are for temporary events, and there are openings on the bottom of the equipment enclosures which could allow accidental access to live electrical components.

Open Knockouts Tour Drops

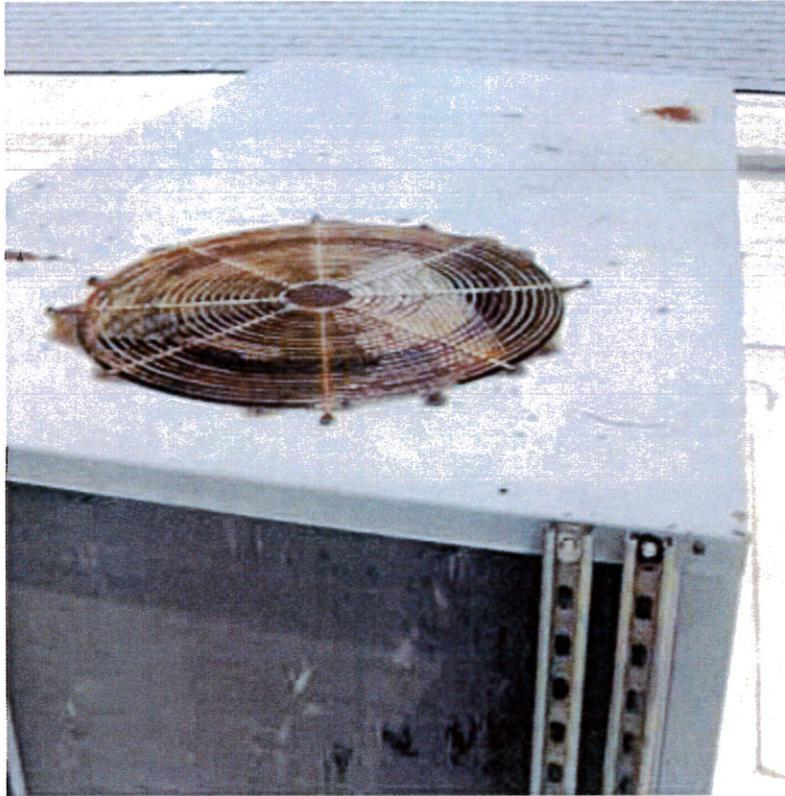
The Conference Center, and adjoining areas of the 1996 addition, are served by a dedicated rooftop unit. The serial number of this unit indicates it is original to 1996, which is in poor condition, and at the end of its useful life expectancy.

Conference Center Rooftop Unit
Unit appears to date to the 1996 addition and is in poor condition.

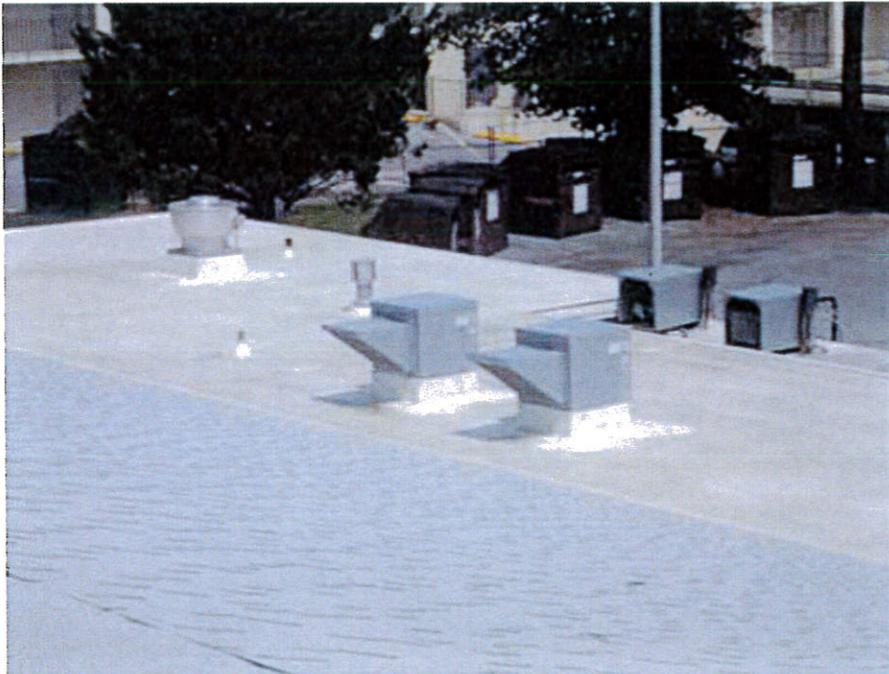
The kitchen hood appears as though it may be original to the building. It does have an ansl fire protection system, with remote control panel. With the canopy being added over the exterior receiving area, the wall-mounted hood exhaust fan now discharges into this semi-confined area, which is not code compliant. The age / operation of the kitchen hood exhaust fan could not be determined, and if original to the building, would be well past its useful life expectancy. Make-up air is provided from roof top units that appear to provide un-tempered air; and appear to be in

Kitchen Roof
Make-up air units appear to provide un-tempered air.

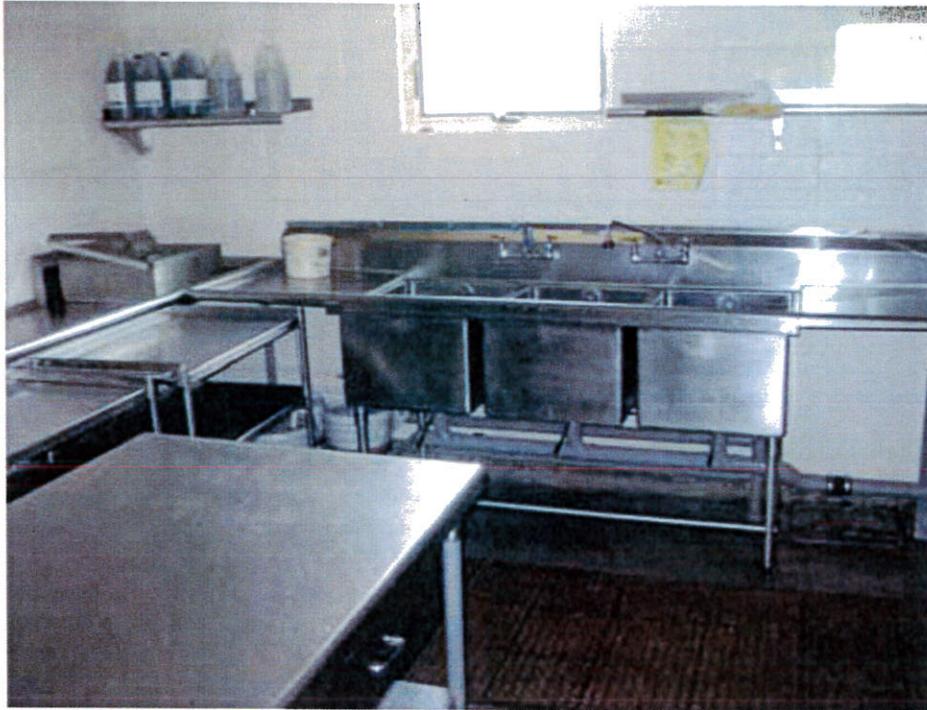
The three-compartment sink and other items in the kitchen require indirect drainage. They are currently hard piped and do not meet code requirements. A grease interceptor was not found, which is also required. The center counter sort of has an indirect waste, but it does not occur at the floor (and is at the bottom shelf).

Three-compartment sink, not provided with code required indirect waste.
Kitchen believed to not have a code required grease interceptor.

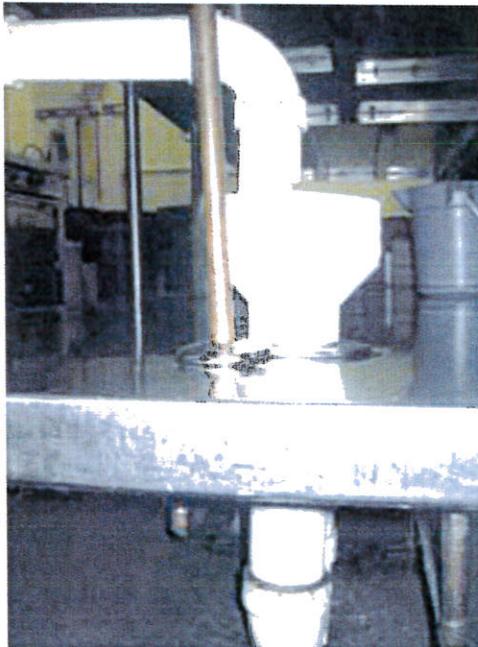
Kitchen Island Counter
Indirect waste just above bottom shelf of counter, and not at floor.

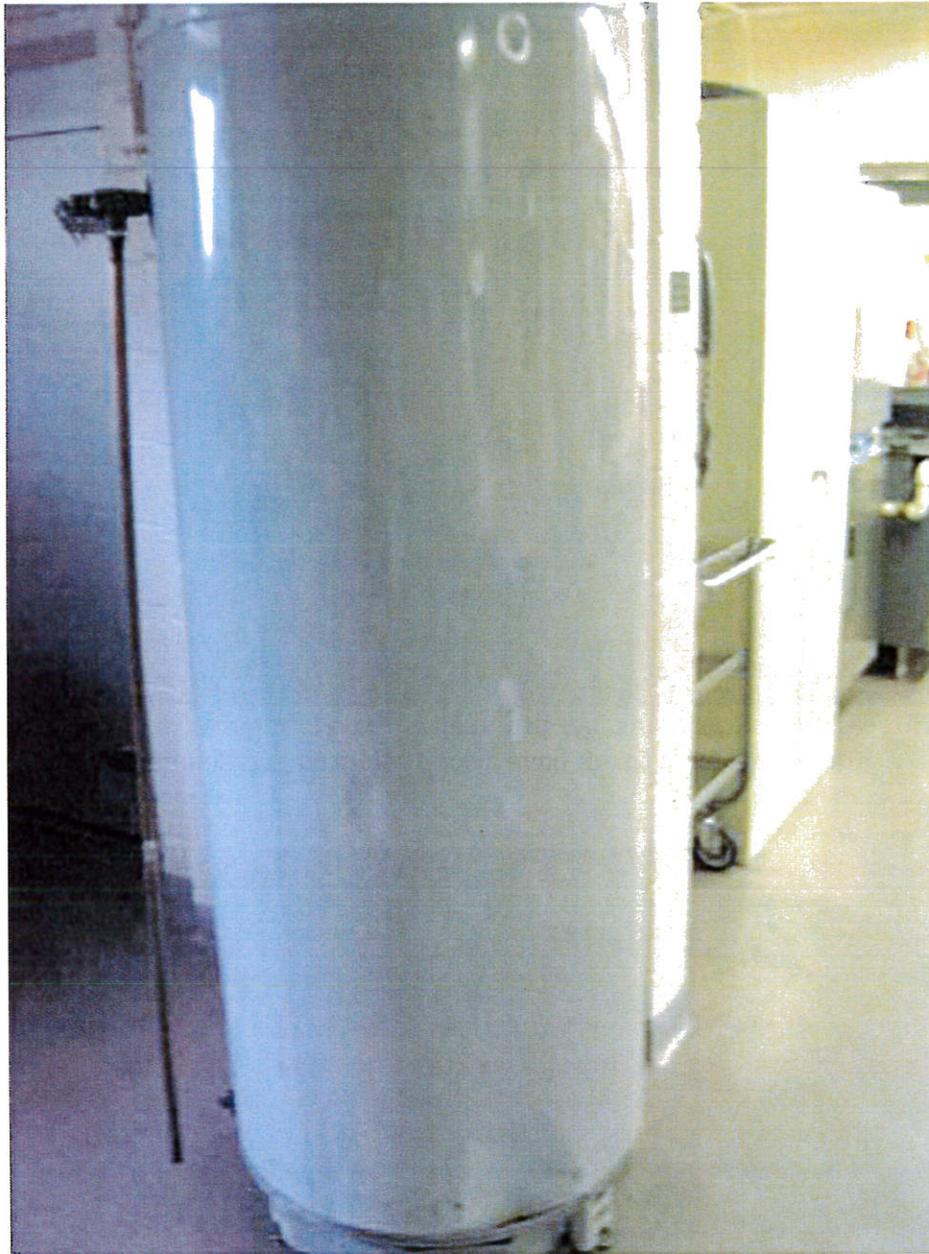
The kitchen is served by a water heater within the space. It is a Bradford White 98 gallon model, which is LP gas fired, and was manufactured in May 1999. In its current location it protrudes into the kitchen circulation area, which has been damaged from carts and other items, and is in poor condition.

Kitchen Water Heater
Poor condition due to being located in circulation area.

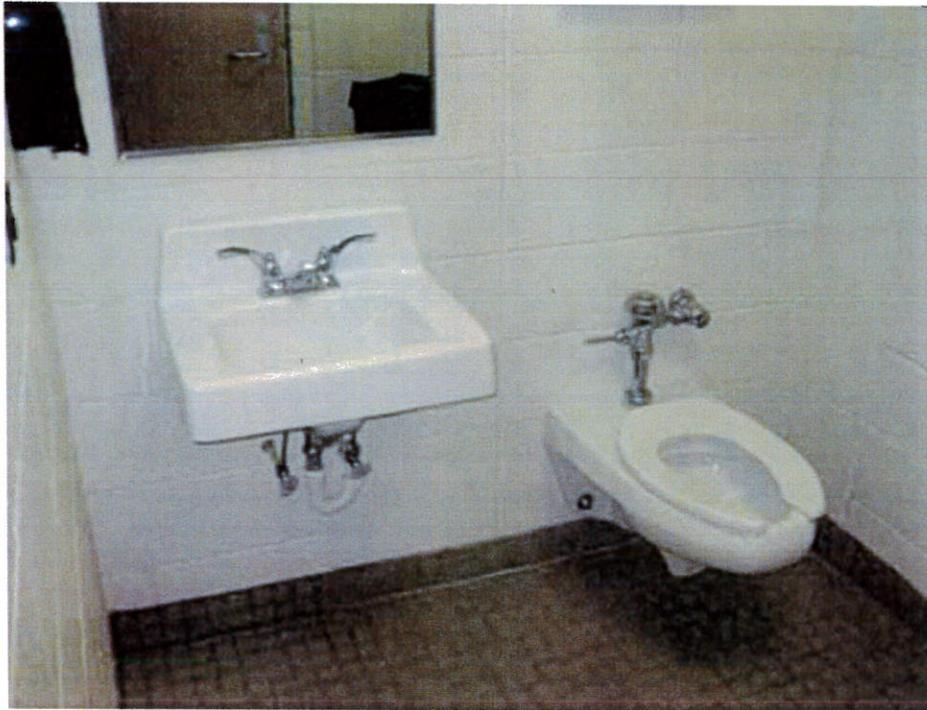
Individual Toilet Room

- Floor mounted water closets, where some are tank-type and some have a flush valve.
- Wall mounted urinals with flush valves.
- Lavatory sinks are wall mounted with wrist blade faucets. Piping below the sinks is not insulated, and therefore does not meet ADA requirements.
- Ceiling exhaust fan interlocked with light switch.

Piping below sink must be insulated to meet ADA requirements.

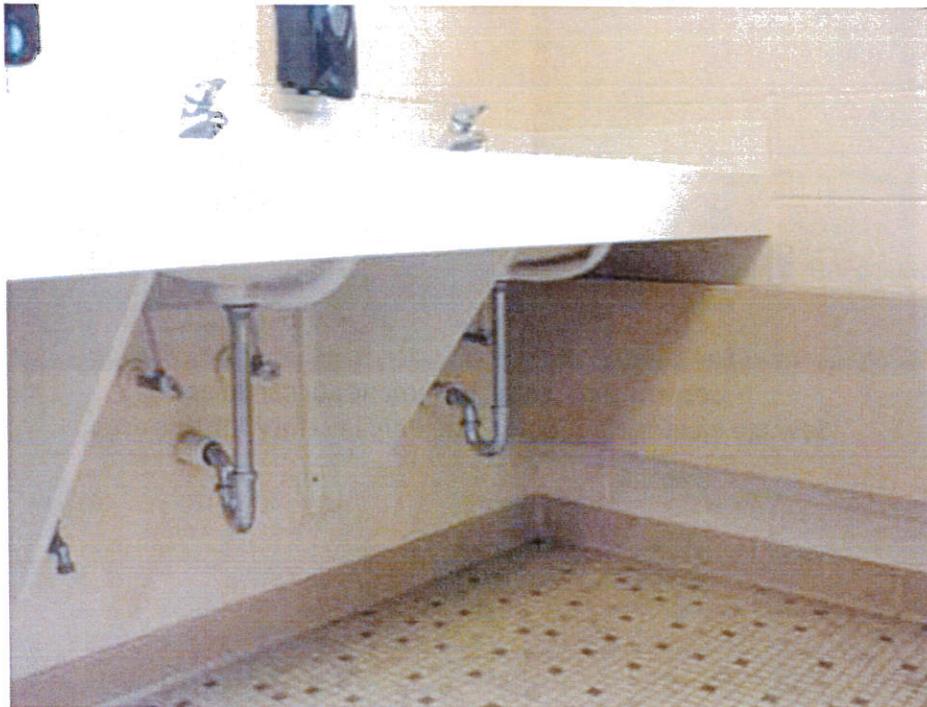
Common Toilet Room in Link

- Floor mounted water closets with flush valves.
- Wall mounted urinals with flush valves.
- Lavatory sinks are counter mounted with single lever faucets. Piping below the counter is not insulated, and therefore does not meet ADA requirements.

Piping below counter must be insulated to meet ADA requirements.

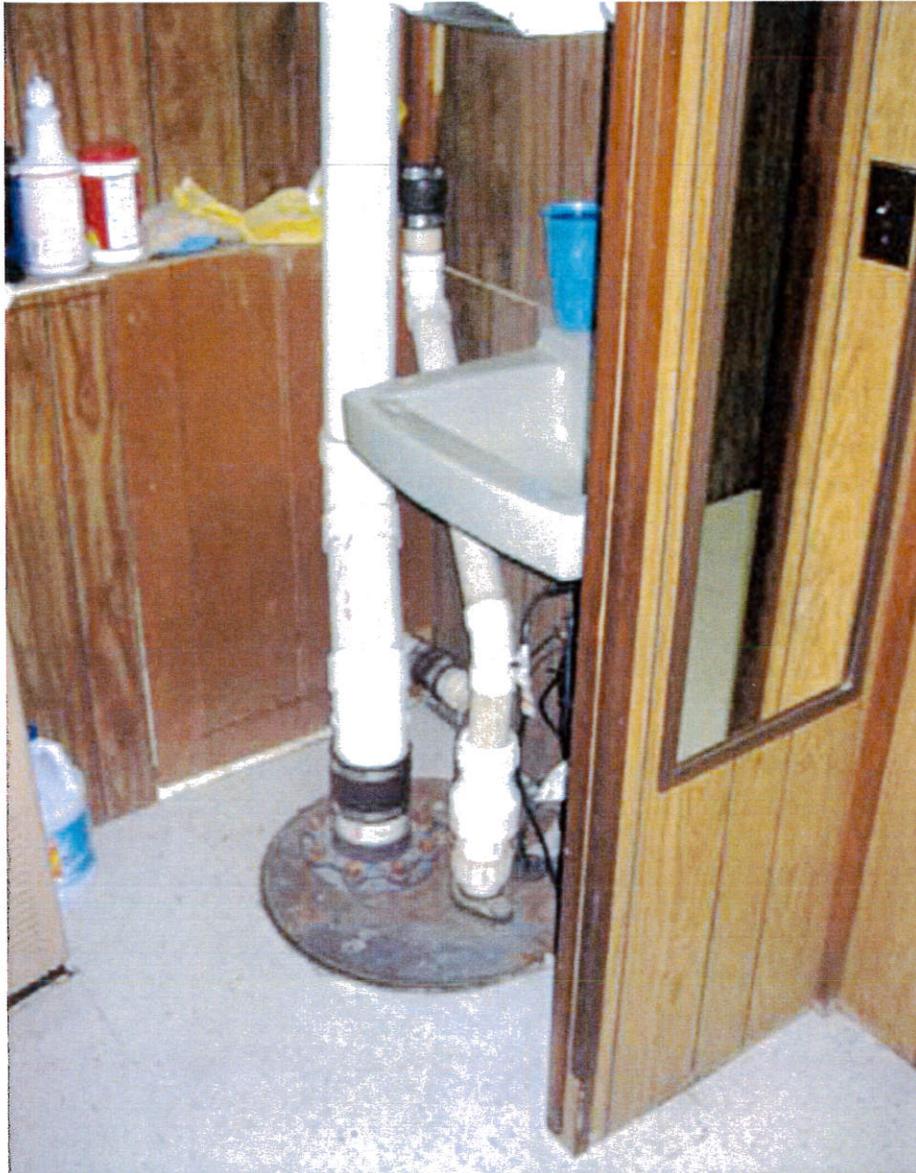
- There is a recessed sewage ejector right below lavatory, with inlet and vent piping hindering access.
- There are two separate toilets installed in narrow rooms with individual light / fan combinations, controlled by common light switch.

Convention Center Basement Locker Area
Sewage ejector right below the only lavatory for this area.
